## Tree report and survey

FOR  
PROPOSED STRATEGIC HOUSING DEVELOPMENT  
AT  
BLACKGLEN ROAD, SANDYFORD, DUBLIN 18.

June 2022

ZOLBURY LIMITED.

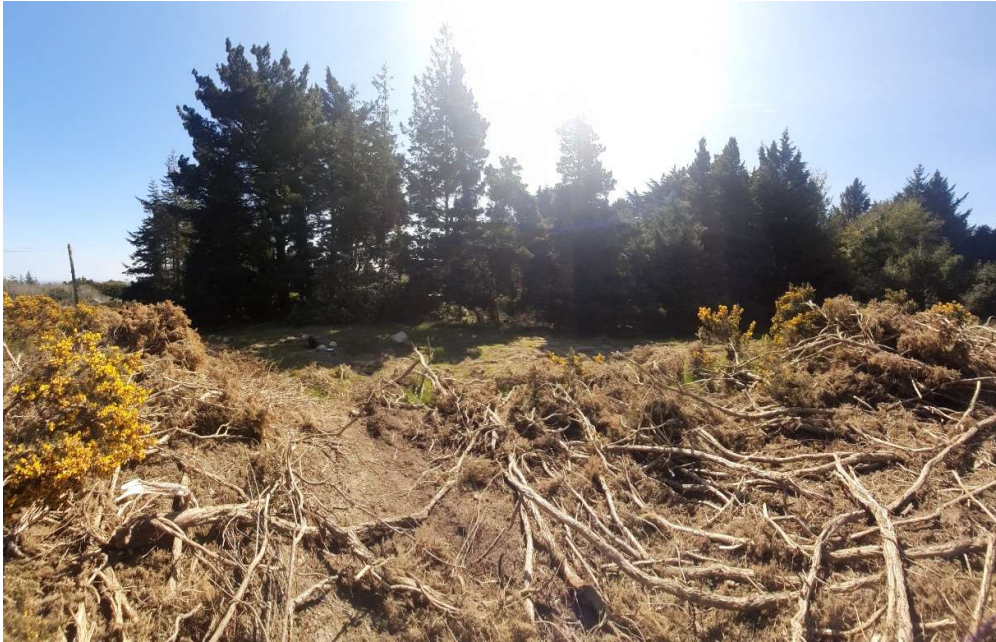
The proposed works along Boundary 2 and to a much less extent along Boundary 3 will require works within the Root Protection Area of some trees. The works along Boundary 2 will be in accordance with The Arboricultural Association Guidance Note 12 "The use of cellular confinement systems near trees – A guide to good practice" and will entail the build up on top of existing ground levels of a cellular geo textile confinement system in a series of geocells arranged in a honeycomb-like formation that is combined with an underlying geotextile and angular stone to spread loads in such a way as to minimise compaction of underlying soil by the proposed carparking. To allow the construction of the new footpaths/carparking/and road along Boundary 2 and 3 the encroachment within these RPAs should equate to less than 20% of the cohesive RPAs. Therefore, the level of impact can be rated low.

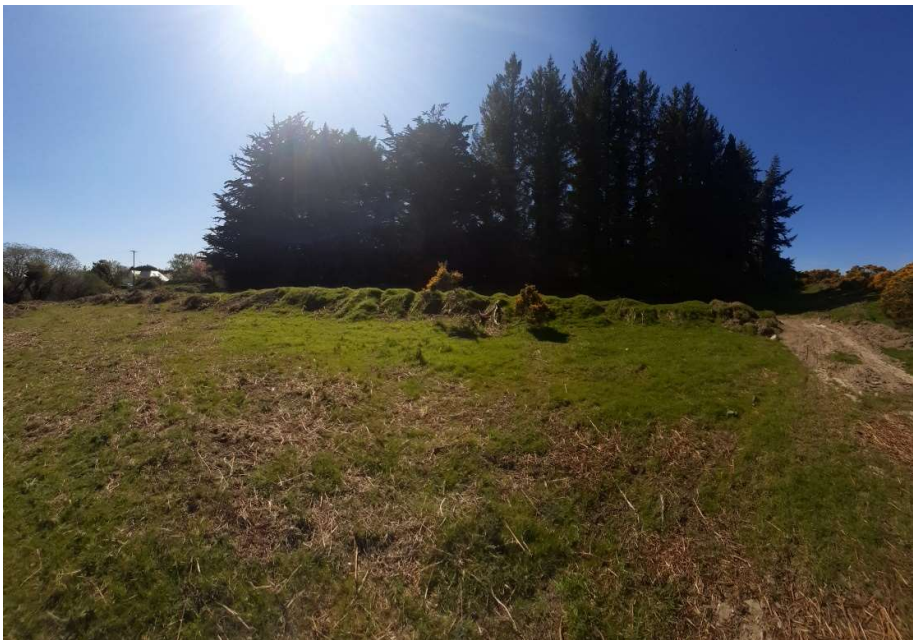
The much smaller works along Boundary 3 will be managed in a similar fashion to Boundary 2.
