**SITE AT
BLACKGLEN ROAD
SANDYFORD**

**ARCHITECTURAL HERITAGE
IMPACT ASSESSMENT**

11th July 2022

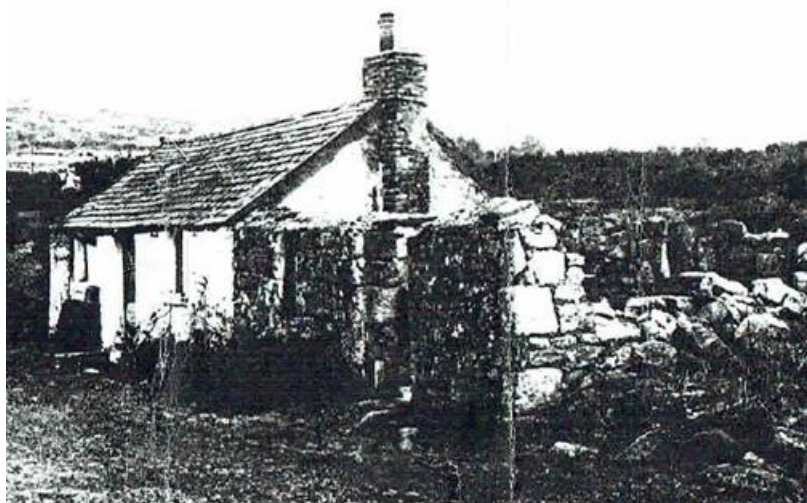
Plate 2: View from the north (Courtesy of Patrick Healy, origin and date of image unknown)

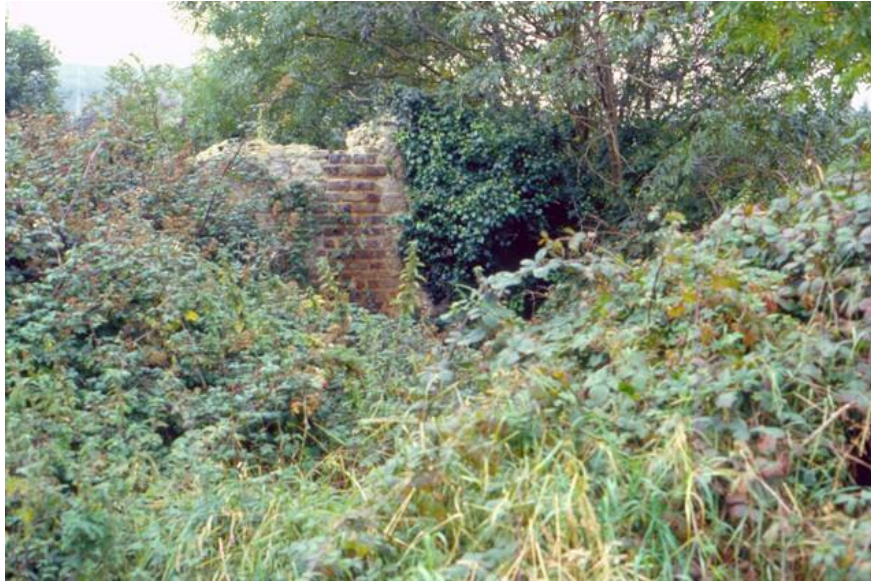
Plate 4: View of the cottage from the north, 1985

The photograph above was taken in 1985, when the structures were barely visible beneath heavy growth of brambles. The masonry that is visible is the party wall, the bricks being part of the lining of the chimney flue of the Markievicz cottage.

Examination of the ruin has not revealed any part of the structure that is in danger of collapse, though the vegetation conceals parts of the buildings, particularly the party wall that carried the chimneybreast. It is noted that the 1985 photograph shows that the chimneybreast had already collapsed by that time, suggesting that it was of brick, which would have provided a thinner wall than if it had been of granite. It is also noted that there has been further collapse in that wall and plate 8 shows a sizeable hole through it that was not evident in 1985.

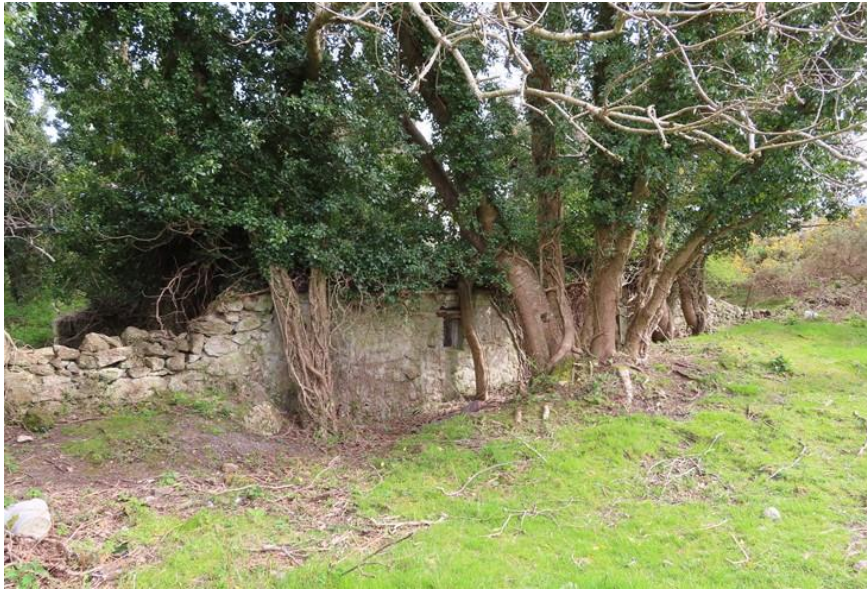
Plate 5: Western side of cottages, seen from application site

The pair of cottages lies near to the boundary with the application site, with one window facing westward over the site. About 1½ metres from the rear wall of the cottages is a low bank on which is growing a multi-stemmed ash tree, probably coppice regrowth having been cut down in the past. A number of other trees are growing close to the wall of the cottages.

In order to eliminate the potential for any accidental damage during construction, a post and rail fence 1.2 metres high is to be erected and the low bank and trees adjacent to the cottage are to be retained as part of the landscaping. This will ensure that no heavy machinery can approach close to the ruins during construction, though the application boundary runs along the rear wall of the ruins and the low bank is within the application site.

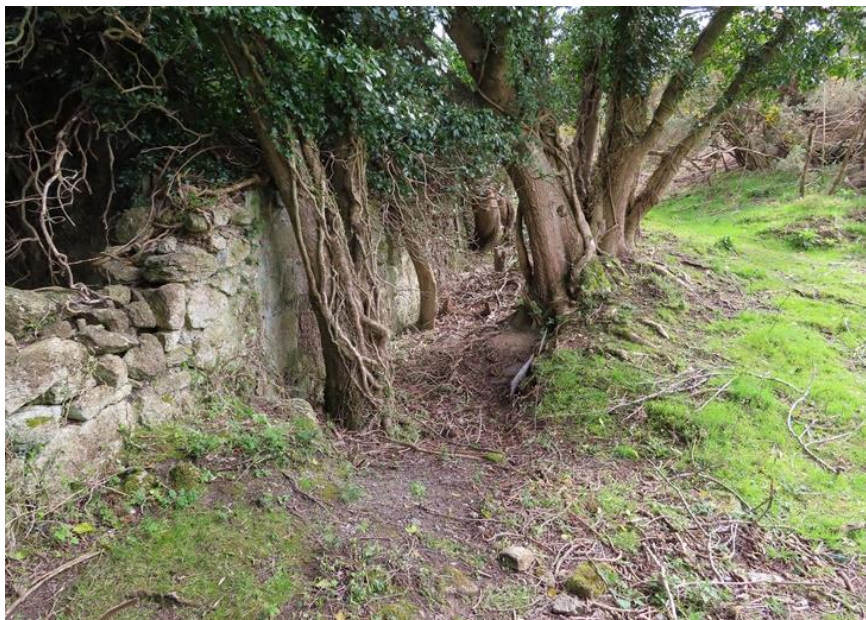
Plate 6: View southward along rear of cottages

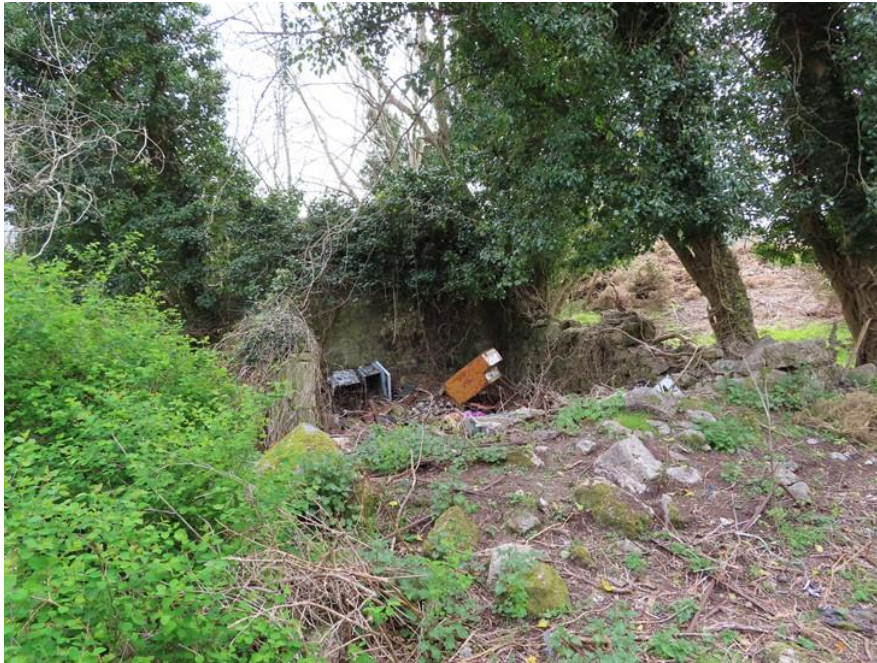
Plate 7: View of Markievicz cottage from the north

The two cottages are built of granite rubble, though with squared granite blocks at the quoins and at the margins of the door and window openings. Squared granite was more readily available than brick in this area where quarrying was a major employer. Brick survives in part of the chimney flue. The photograph above is taken from the same place as the 1985 photograph in plate 4 above, though there has been a reversal in the vegetation, with the top of the party wall now concealed and the rest of the masonry visible. The photograph below shows squared granite quoins, while in the distance squared blocks are seen at the door jamb, at left and at the side of the window opening beyond it.

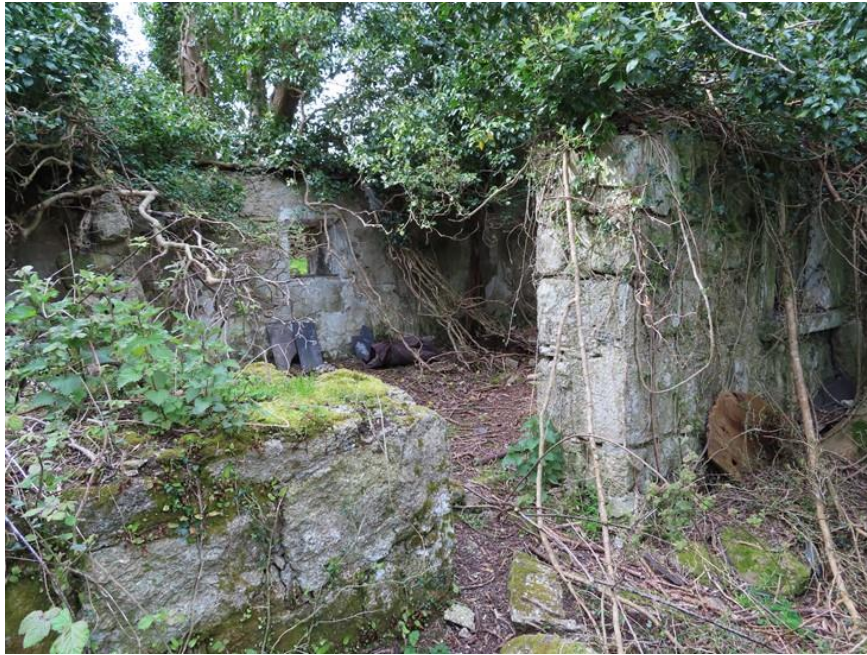
Plate 9: Mrs Mary Mulligan's cottage

The southern of the two cottages is the one that was occupied by Mary Mulligan, as seen in the newspaper articles from 1953 and 1961. This is built with similar materials to the Markiewicz cottage, and the squared granite of the opening is seen in the photograph above.

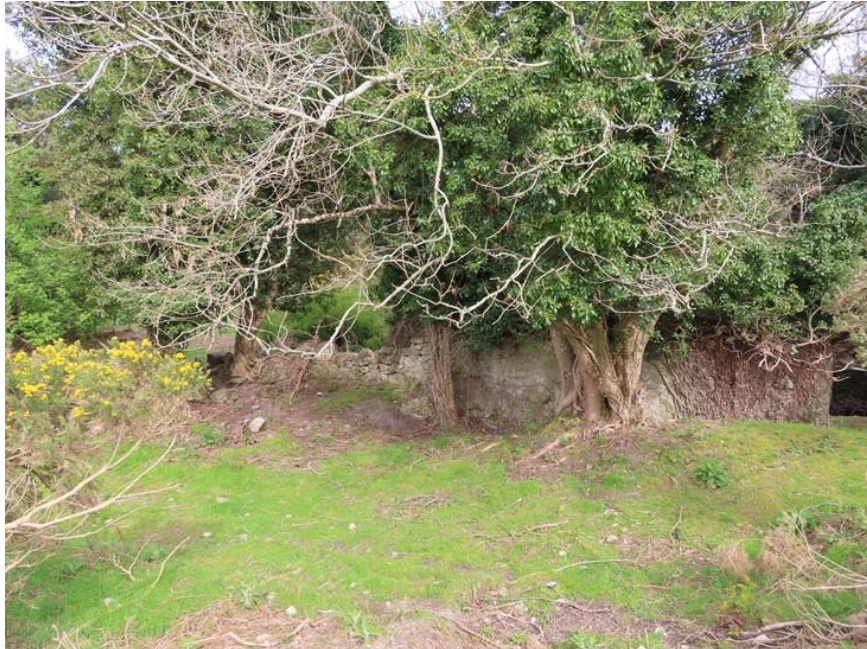
Plate 10: Cottages as seen from the application site

The other potential source of damage could be vibration caused by blasting or rock breaking. The site is for the most part outcropping granite with a thin soil cover and much of the site slopes steeply. In order to provide the platform for the spine road and reasonable gradients it will be necessary to regrade the land, and this is also likely to provide suitable bases for the apartment buildings. Care will need to be taken to ensure that vibration levels are not of such a magnitude as to result in collapse of the masonry of the cottages.
